# Manhole Inspection Summary

Manhole # S17C1\_015MH

Insp Date: **5/15/08 10:10 AM**

**Location** Address: **2803 carroll st**

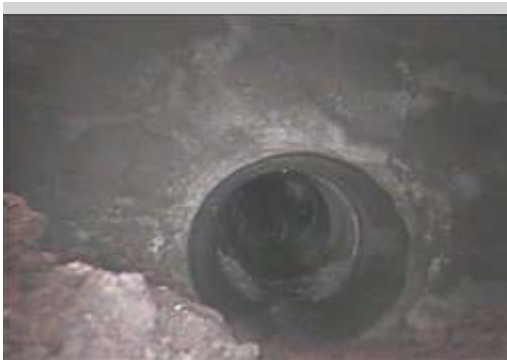
Defect

Condition: ☐ Sound ☐ Cracked ☐ Root Intrusion ☐ Deteriorated ☐ Leaks ☒ **Debris**

channel debris

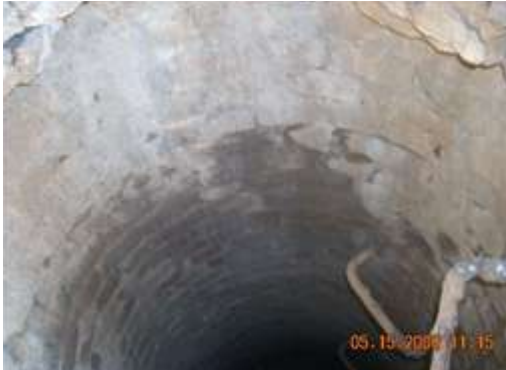
Defect 3

Infiltration: ☐ None ☐ Joint ☐ Cracks ☐ Mortar ☐ Roots ☒ **Wall**

infiltration @ corbel wall

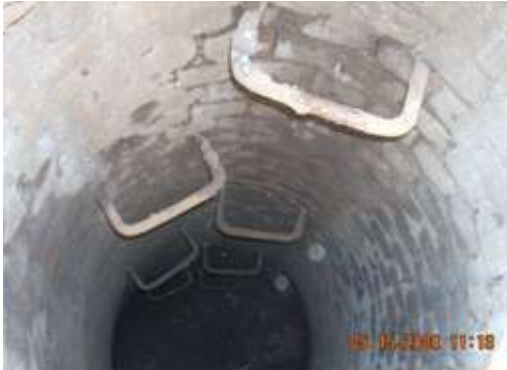
Defect 2

Count: **7** Missing: **0** ☒ **Corroded**

corroded steps

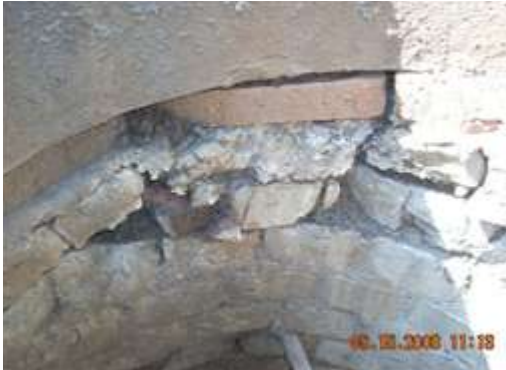
Defect 1

Condition: ☐ Sound ☒ **Cracked** ☐ Root Intrusion ☐ Loose Brick ☐ Deteriorated

cracked chimney bricks

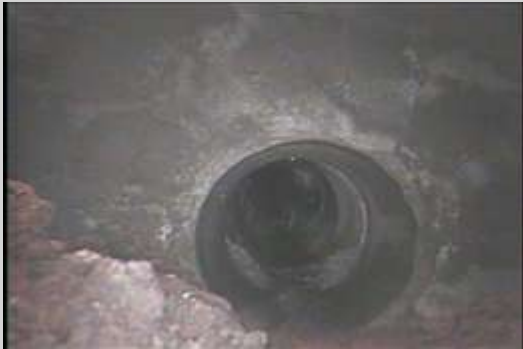
12 O'Clock Outflow

Deposits: ☐ None ☒ **Mud** ☐ Sludge ☐ Debris ☐ Grease

Silt Depth: **2** (in.) Deposits Extent: **Light**
